# S.O.S.

News from the  
**Friends of the Newport Ship**

**No. 21**  
September 2013

# Summary of Newport Medieval Ship Specialist Report Information

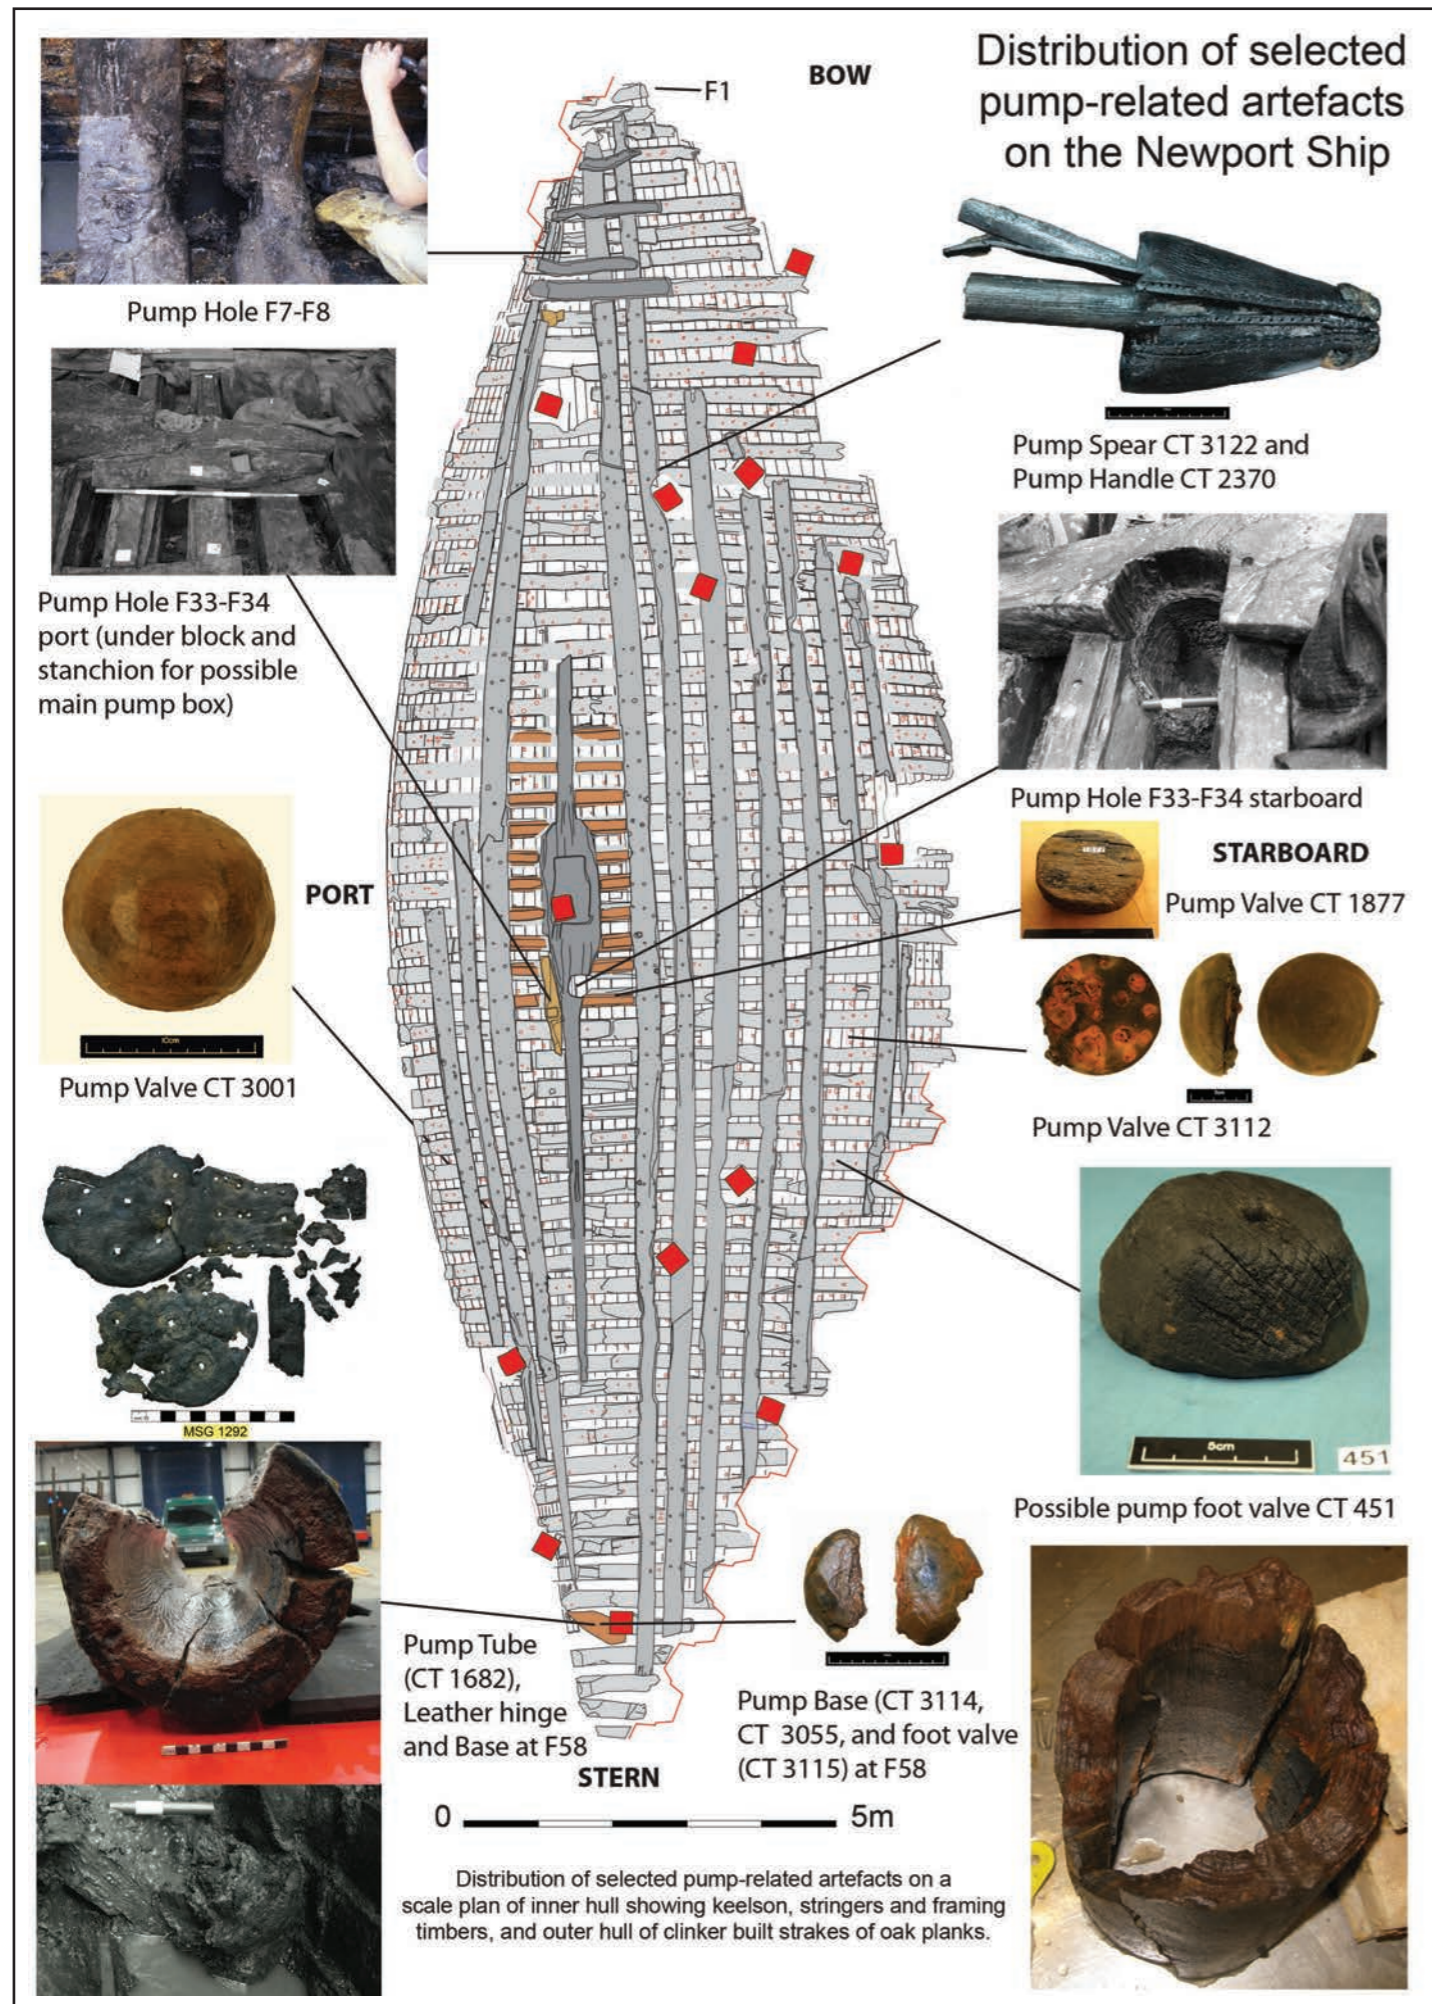
The minimum hypothetical reconstruction of the Newport Medieval Ship created by Pat Tanner.  
See pages 8 - 9 for more of Pat's excellent reconstruction drawings

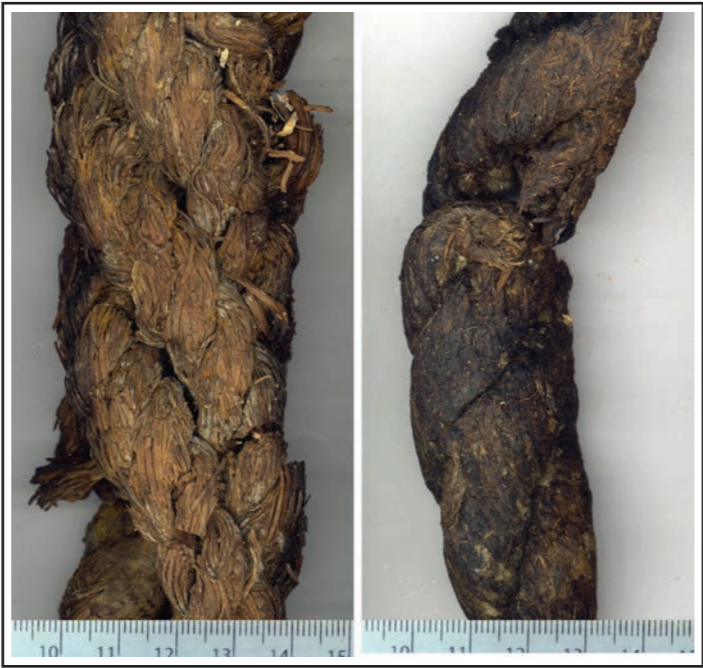
Illustration: Rope

Ships carried a large amount of cordage in the form of running and standing rigging, though it is rare to find substantial quantities of cordage surviving from archaeological contexts. The upper works of a vessel are often the first to degrade after a ship has been abandoned. Ropes are also salvaged for reuse. However, a substantial and diverse range of cordage was discovered during the excavation, both inside and underneath the vessel. The recovered cordage was made from either grass or hemp and ranged in size from 12mm to 40mm in diameter. The smaller ropes were used in the running and standing rigging, while the largest ropes, known as hawsers, were used for mooring and towing. Some rigging elements, including a pulley, were found to have fragments of rope still in situ.

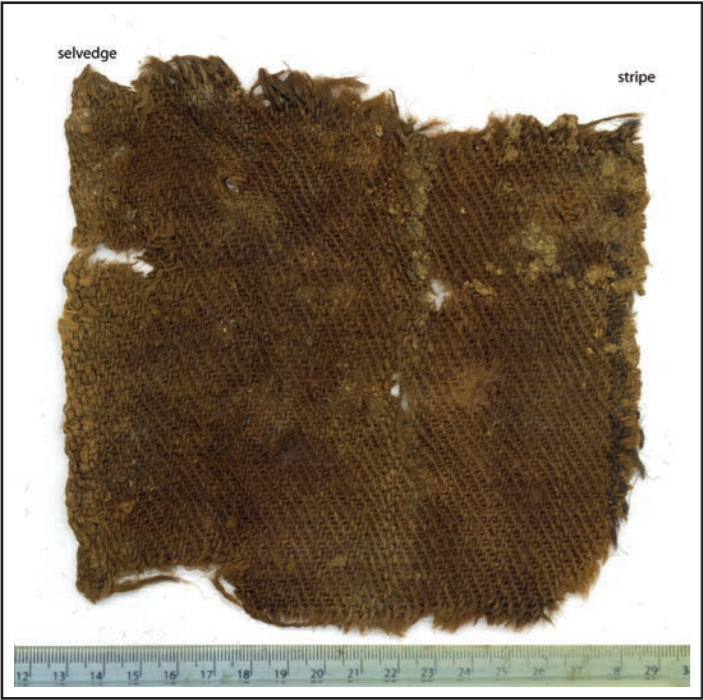
Illustration: Textile

Most of the textiles found during the ship excavation are fragments of well-spun natural-colour wool, woven into a heavy, coarse cloth ideally suited for making durable work clothes required by mariners. The textiles were all woven using a 2/2 twill weave or a tabby weave. Several examples have darker stripes surrounded by a lighter background. Most of the textile fragments seem to have been serving secondary purposes, such as plugging leaks, indicating that the sailors were resourceful in the reuse of worn out clothing.

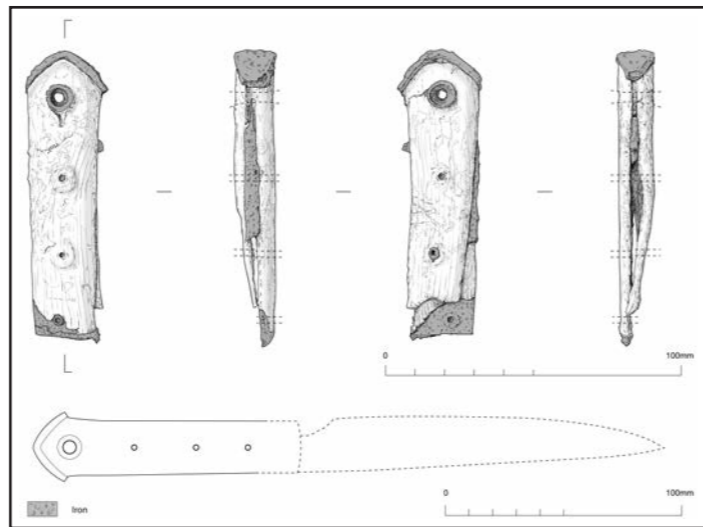
**Knife Handle from the Newport Ship**

The boxwood knife handle corresponds closely with other mid-15<sup>th</sup> century examples. A replica of the knife was created by Hector Cole, the same blacksmith who made the set of medieval shipbuilding tools on display at the ship centre. (High-quality handmade replicas of the Newport Ship Knife are available, contact the ship centre if interested).

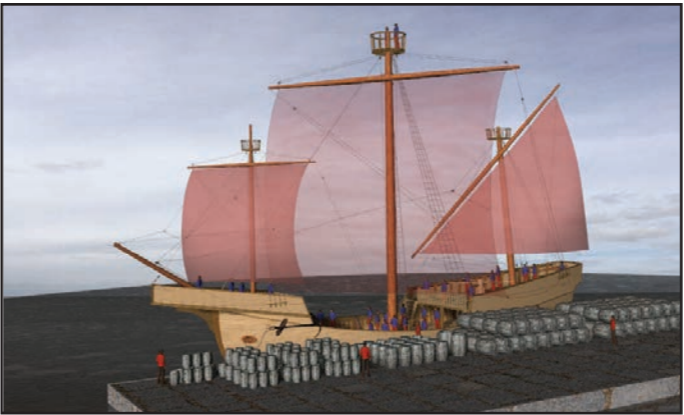
Cargo capacity of the Newport Ship

The recreation of the original hull form within the digital world has allowed for the use of sophisticated software to analyse the cargo capacity, sea keeping characteristics and performance of the vessel in a variety of situations. The hull was tested as an empty shell, ballasted, and fully laden, all states that it would have regularly experienced during its working life. The vessel was found to have a notional cargo capacity of between 107-141 metric tons, with an additional 17 tonnes of ballast. The total deadweight of the ship, when fully loaded, would have been around 207 tonnes. The main sail was estimated to be around 264 square metres, which would have required up to 31 mariners to handle. This amount of sail could propel the ship fully laden at a speed of 6-7 knots in a Force 3 wind (blowing 9-10 knots), when sailing downwind (assuming a clean and smooth hull). The additional sail area of a fore and mizzen mast would have increased speed and, more importantly, made the ship more effective when sailing to the windward. It is important to remember that these numbers are based on a minimum reconstruction, and represent the lower end of the ship's capacity and speed capabilities, when compared to the capacity and performance of a capital reconstruction. It should be noted that the numbers are also computer-modelled statistics, and are based on the hull being clean and smooth, a characteristic rarely, if ever, achieved in the medieval real world.

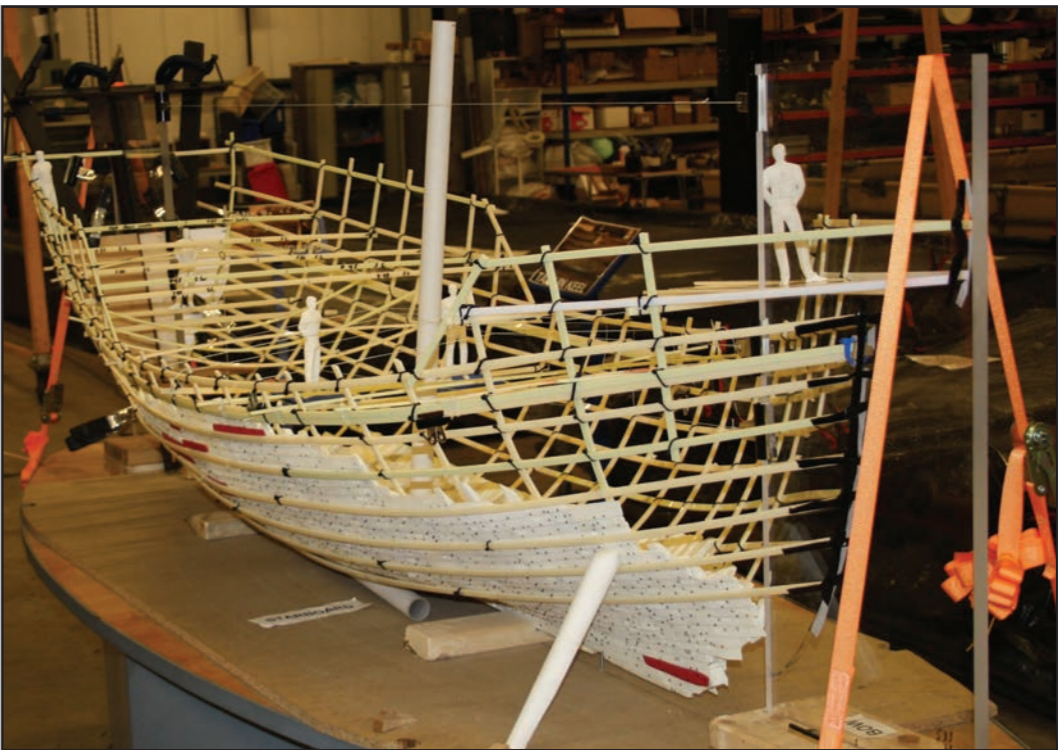
A minimum hull reconstruction was created using innovative digital modelling methods. Project staff created a 1:10 scale physical model of the extant hull remains using a process of digital solid modelling and a form of additive manufacturing (3D printing) called selective laser sintering. Using this model, the staff ghosted in the missing areas of the hull using long plastic ribbands. A reasonably-faired complete hull form was achieved, which was then digitised (laser scanned). This digital model of the complete hull was then used by Pat Tanner as a starting point for repairing the localised damage and twist present in the model, in an effort to create an ideal hull form representing the ship when it was newly built. Additionally, Erica McCarthy produced a detailed catalogue of the artefacts related to the rigging, which provided clues about how the ship was rigged.

Scale model of the Newport Ship made from digital recordings.

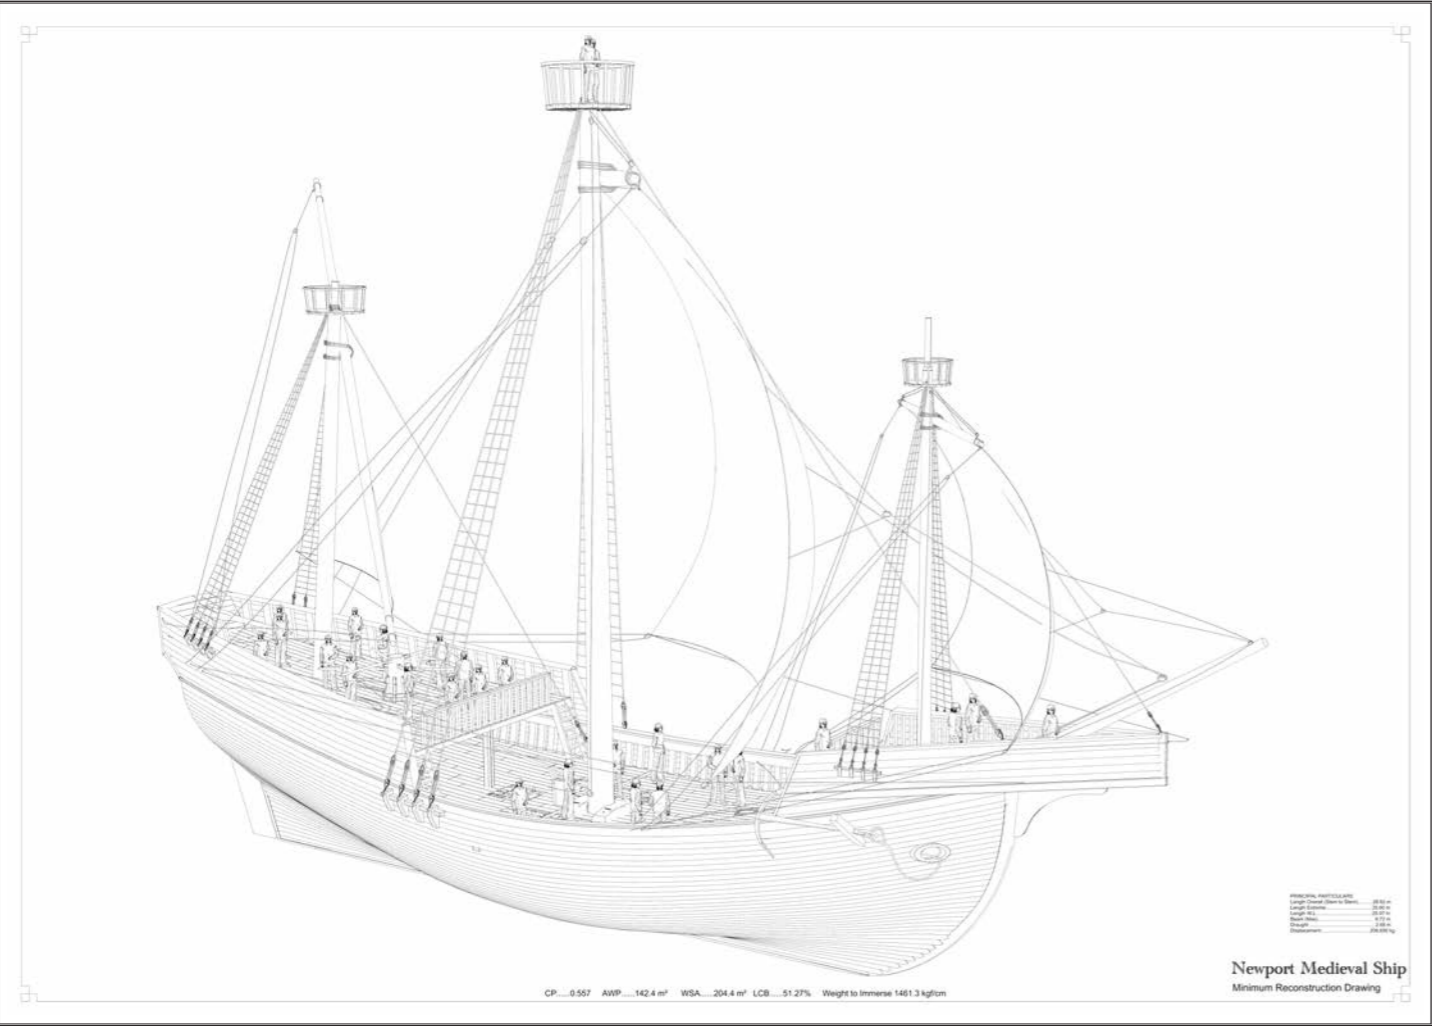
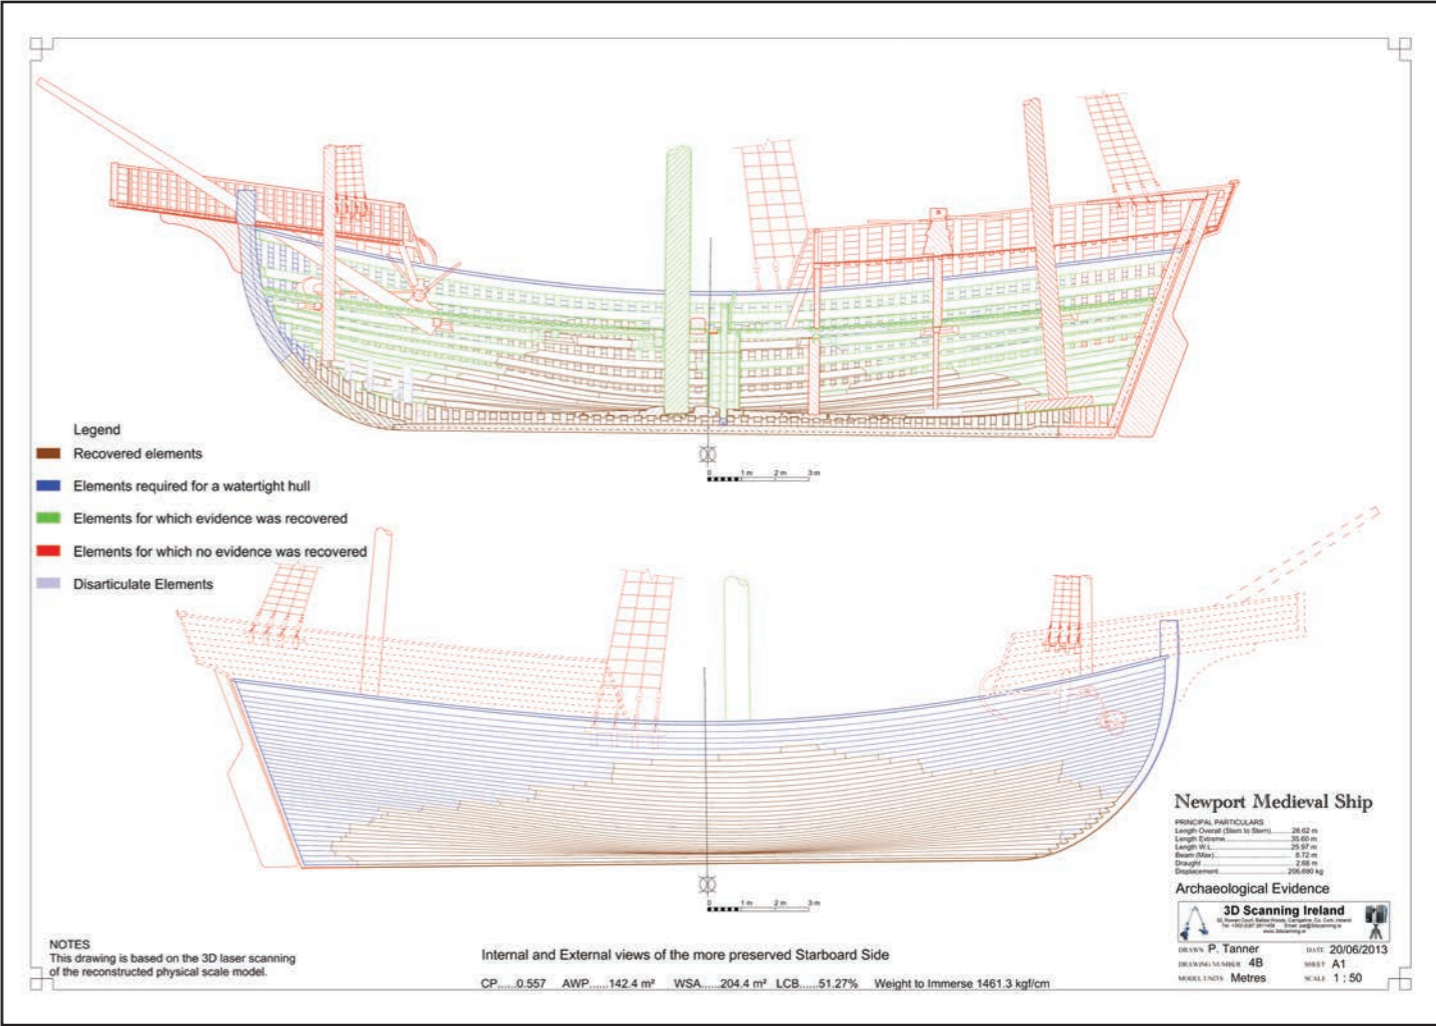
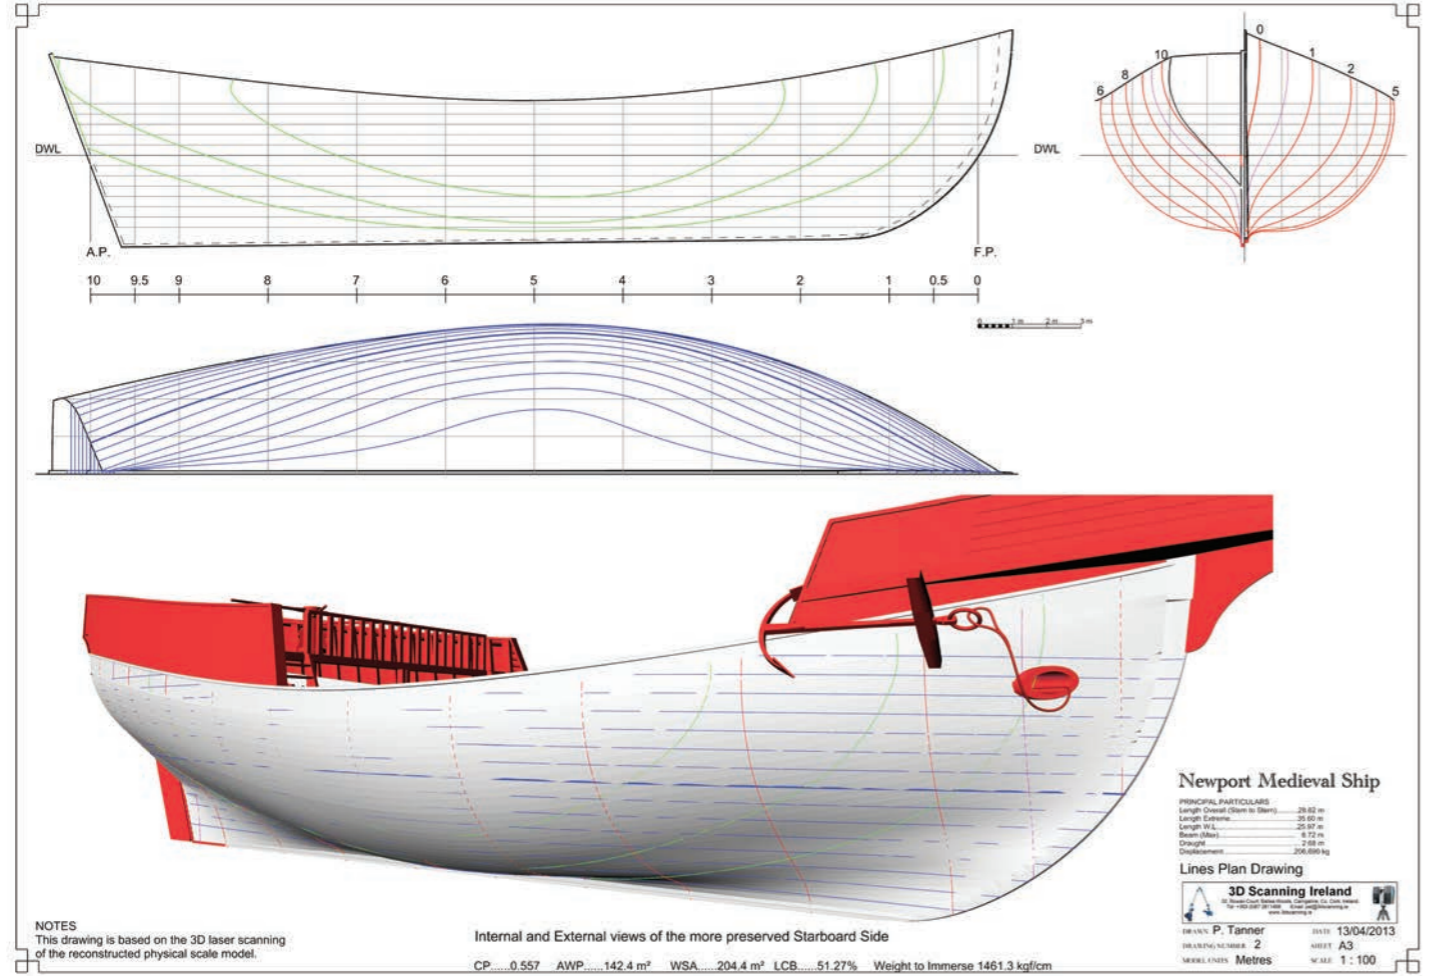
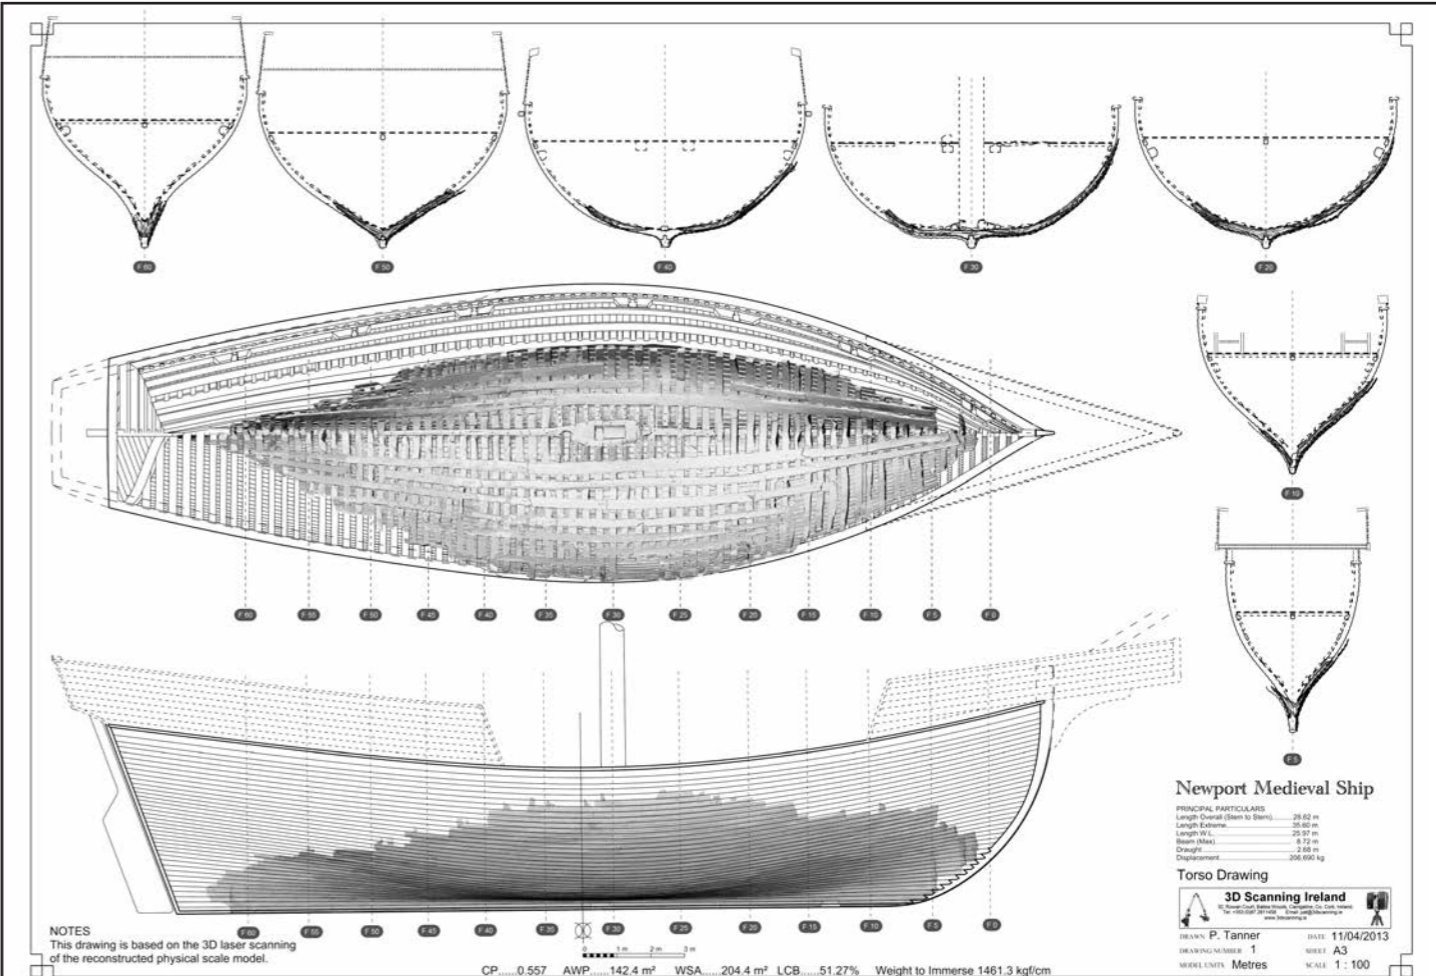
Reconstruction drawings of the Newport Ship by Pat Tanner.
